Maritime Access to Congo – State of Affairs*

Jean Jacques PETERS**

KEYWORDS. — Congo; Ports; Dredging.

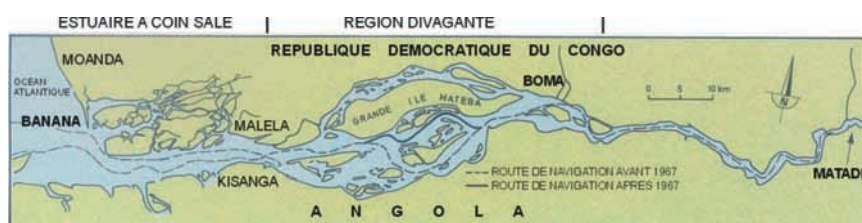
Fig. 1. — The maritime reach of the Congo River, with its very deep submarine canyon, its braided, wandering area (Malela to Boma) and its deep stretch (Boma to Matadi).

On 5 December 1986, the Royal Academy for Overseas Sciences organized a very successful symposium about the maritime access to Congo, called Zaire at that time. In the presentations, various aspects were treated, among which the dredging works needed to ensure a sufficient navigation depth for seagoing vessels sailing to and from the ports of Boma and Matadi. Dredging of the fairway is only required in the *Région Divagante*, the wandering region of the river with very mobile sandbars and shallow crossings (also called sills or riffles) in the navigation route. This area is the transition between the port of Boma and the very deep submarine canyon that penetrates 30 km inland. Further upstream towards Matadi, the river is deep enough, entrenched between rocky banks (fig. 1).

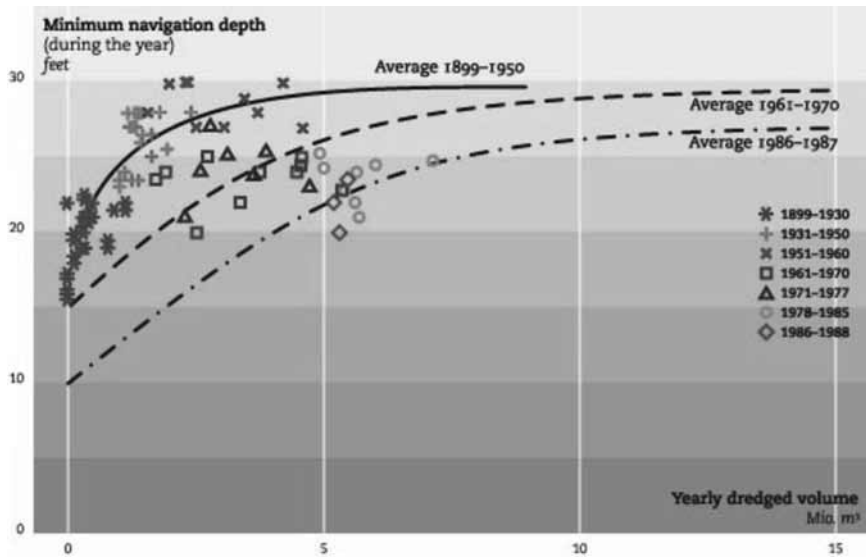
Fig. 9. — Relationships between the dredging effort during a given year (in millions of m^3) and the minimum draught observed during that year (in feet).

In the graph of figure 9, it can be observed that period 1899-1950 may be considered as very favourable, while 1986-1988 was very unfavourable. The strategy developed by the hydraulic laboratories of Borgerhout and Châtelet in the Mateba project aims at using dredging as a tool to steer morphology, enhancing the natural trends when they seem positive, countering them when they seem negative (as was done in 1989-1990, see above). Dredging is not only to keep the target depth on crossings, but also to influence the morphology so that self-dredging capacity would be maximized and dredging effort kept as low as possible. During the work of the CSD Kallo, the edge of a steep sandbar, which was ready to collapse, was cut away (against the natural movement of the sandbar) and the dredged sand deposited in secondary channels. These were enlarging dangerously at that time, diverting significant flow and reducing thus the self-dredging capacity in the main channel used for navigation. This kind of strategy is not common elsewhere.

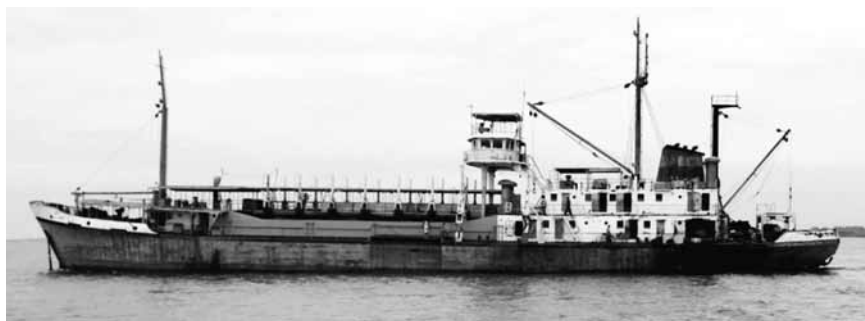
Fig. 11. — Trailing suction hopper dredger Banana (date of construction, 1971).

sonnel. The assistance promised by Belgium will produce results in the medium term. Besides, there is the need to plan already today the progressive renewal of the means and tools to make RVM a more modern and efficient company. External assistance will be further needed. The oldest trailing suction hopper dredger, Banana (fig. 11), is getting old and its sister-ship Mayumbe was decommissioned years ago. Poor maintenance is obviously the main reason for the ageing of RVM dredgers. Nonetheless, RVM must consider the procurement of at least one additional dredger in order to be able to maintain a safe navigation route when the river's morphology is unfavourable.
